## STINSON 108-1 WITH FRANKLIN 150 HP ENGINE STINSON 108-2/3 WITH FRANKLIN 165 HP ENGINE

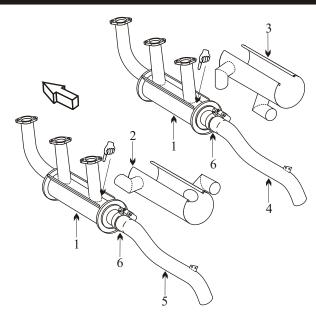
Item	Part Number	Description	
1	108-6221702	Muffler	SN <sup>108-1</sup> <sub>3109</sub>
NS	108-6222702	Muffler	SN <sup>108-3110</sup> and on
2	108-6221209	SHROUD ASSY CABIN HEAT	Γ
3	108-6221210	SHROUD ASSY CARB HEAT	
NS	108-6221210-2	SHROUD ASSY CARB HEAT	SN <sup>2250</sup> and on
4	108-6221711-1	TAILPIPE RIGHT HAND	$SN_{3109}^{108-112}$
5	108-6221711-0	TAILPIPE LEFT HAND	$SN_{3109}^{108-112}$
NS	108-6222711-1	TAILPIPE RIGHT HAND	SN <sup>3110</sup> and on
NS	108-6222711-0	TAILPIPE LEFT HAND	SN <sup>3110</sup> and on
6	108-6222715	CLAMP ASSY TAILPIPE	
NS	108-6221807	CARB AIR BOX	SN <sup>108-1</sup> <sub>2249</sub>
NS	108-6222807	CARB AIR BOX	SN <sup>2250</sup> and on
NS	108-6211000	ENGINE MOUNT	
NS	108-6212000	ENGINE MOUNT	·

- Inspect flanges for corrosion as they could be mild steel not stainless steel.
- Inspect joints for freedom of movement and distortion.

Inspect the area where riser attaches to the body of the muffler for cracks.
