STINSON SM1B

WITH LYCOMING 785 SR9 ENGINE

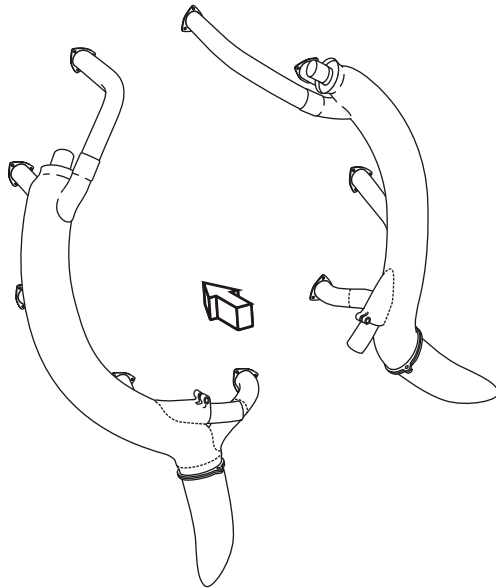
Item	Part Number	Description
1		Exhaust System

- The stack assembly and flanges are most likely mild steel and not stainless steel. Inspect for thinning and corrosion.
